DESCRIPTION	CONTRACT PRICE	INVOICED	CASH RECEIVED	BALANCE DUE
To Waterproofing face of front wall 184 ft. x 45' high 8280 sq.ft. authorized letter from Mr. McGill dated Sept. 21st, 1936.	20¢/sq.ft.	1656.00		
Waterproofing face of east wall 2790 sq.ft. say 2500 sq.ft. authorized letter from Mr. Orr dated October 9th, 1936.	20¢ unit	500.00		
Waterproofing parapets Chapel, and north and west walls of School, authorized letter from Mr. Orr dated October 19th, 1936		150.00		
		<u>\$2306.00</u>

Re: Indian Residential School
Shubenacadie, Nova Scotia

WET WALLS

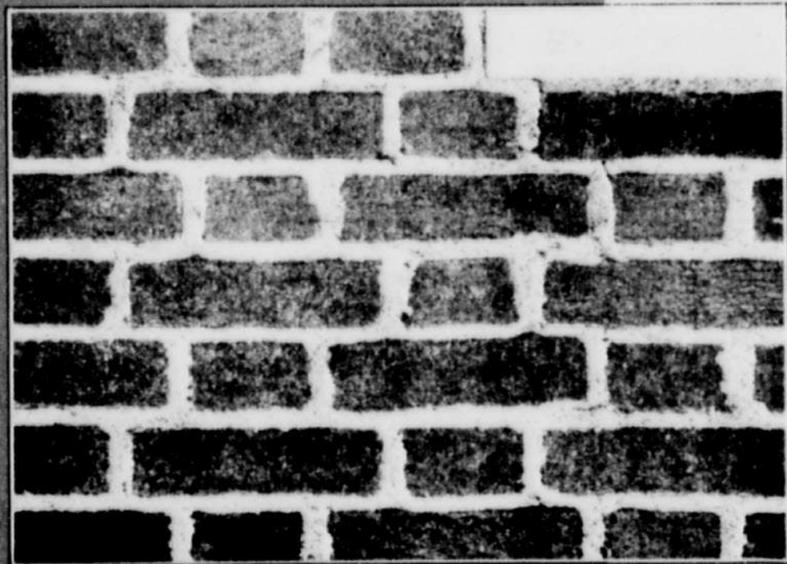
Typical Unrepaired Wall (openings estimated at 1/2 of 1% of total wall area)

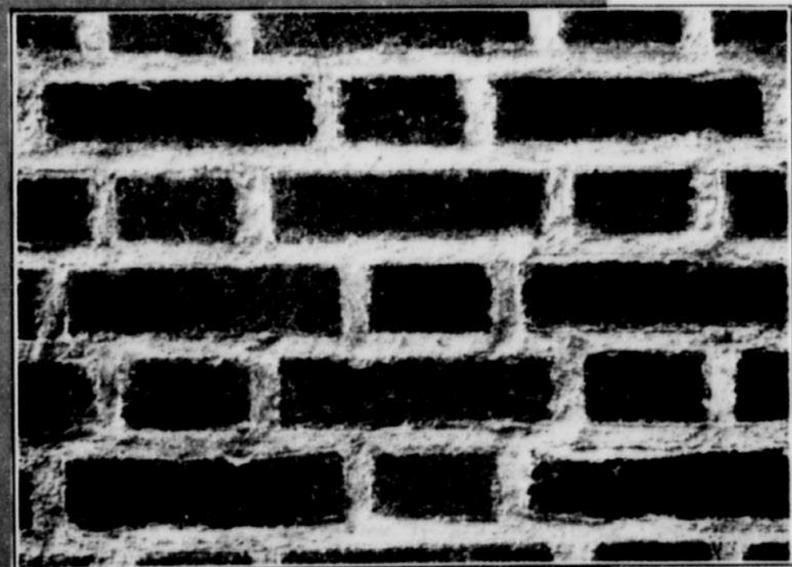
Openings closed with Resto-Crete

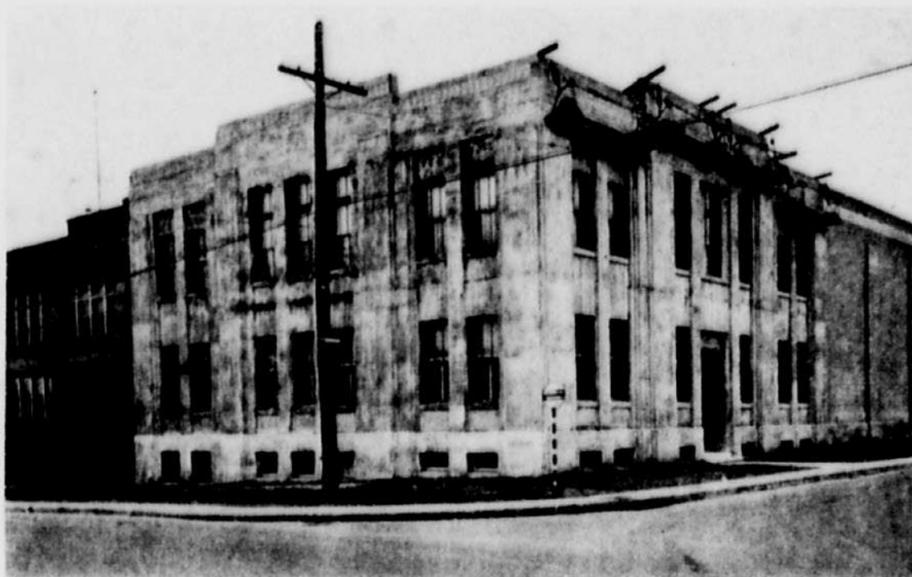
BEFORE TREATMENT — Associated Screen News Building, Montreal.

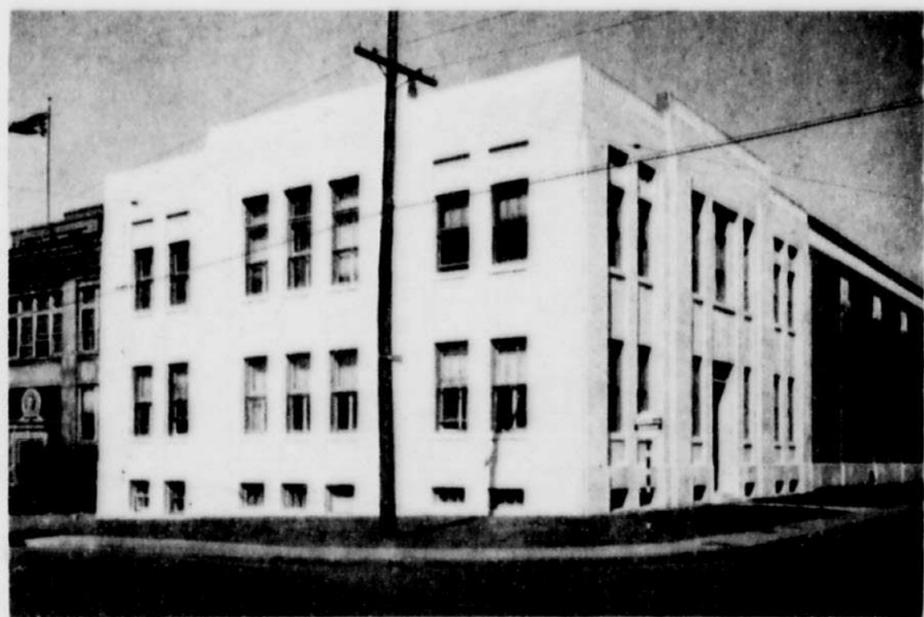
AFTER TREATMENT — Beauty, protection and permanence given monolithic reinforced concrete structure without added plaster or skin coat. Building designed by the Engineering Staff of the Canadian Pacific Ry. Co.

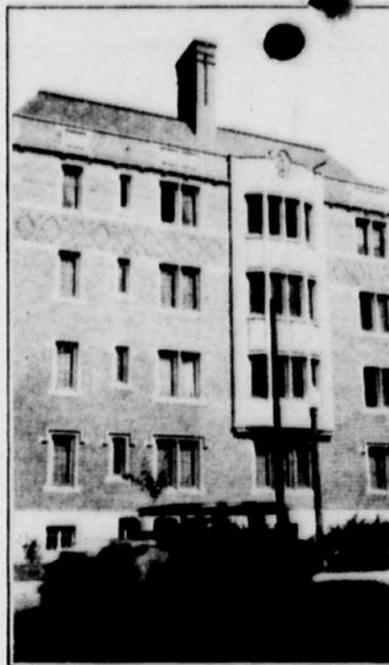
Complete Resto-Crete job on brick, mortar, artificial stone and concrete.

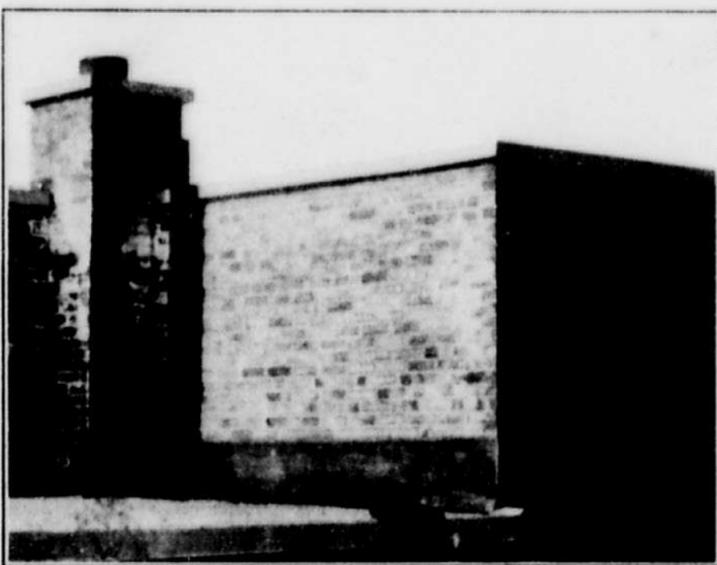
Showing improved appearance by elimination of efflorescence.

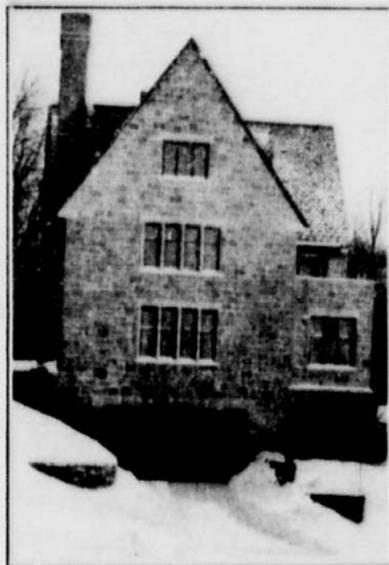
About half the complete surface shown has been weatherproofed with Resto-Crete without altering appearance.

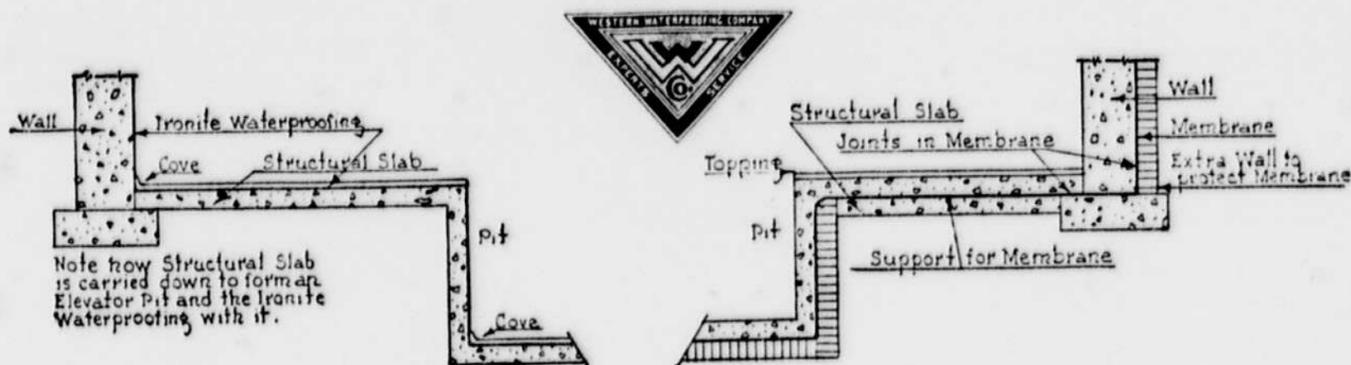
With Ironite

No Joints or Seams.

Ironite Coating Can Be Punctured and Easily Repaired.

A Leak Can Be Immediately Seen and Remedied.

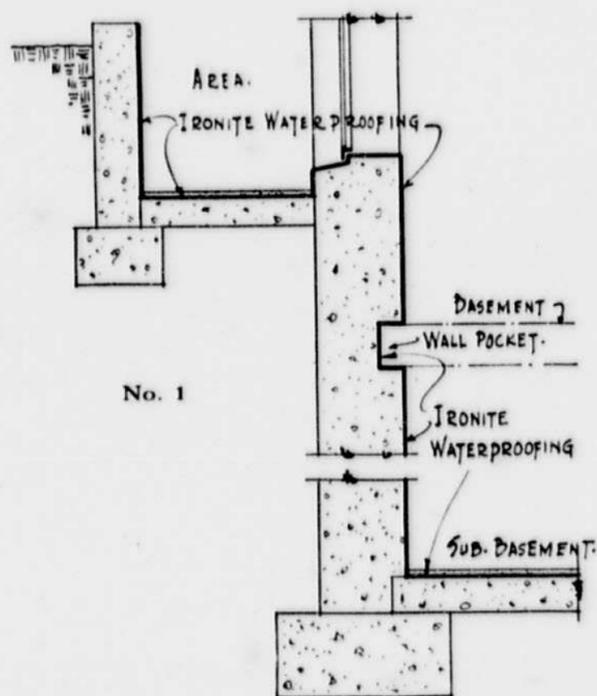
Diagram No. 1 shows the manner of carrying the waterproofing into the wall pocket for

the basement floor on a multi-basement building. It also indicates how the waterproofing is made continuous when areaways and areaway windows are encountered.

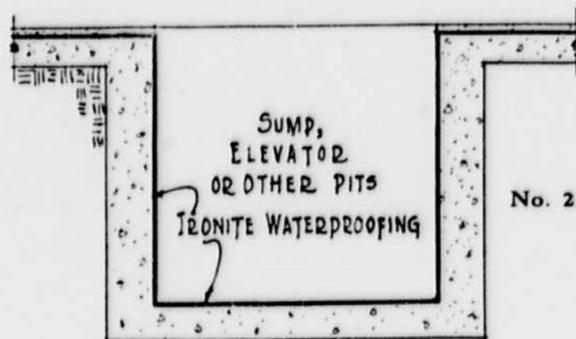
No. 2 is a typical pit waterproofed. Note here that the floor of the pit has no topping over the waterproofing, as no wearing occurs here. On the main floor level, however, the topping appears and is needed for wear.

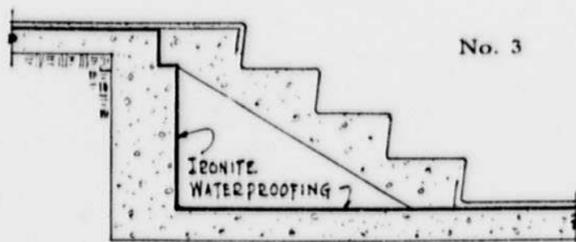
No. 3 shows the best way for waterproofing interior stairs by carrying the treatment under and behind the stairs. If necessary the treatment could be applied to the treads and risers of the stairs, but for economy and best results we recommend doing the waterproofing as shown.

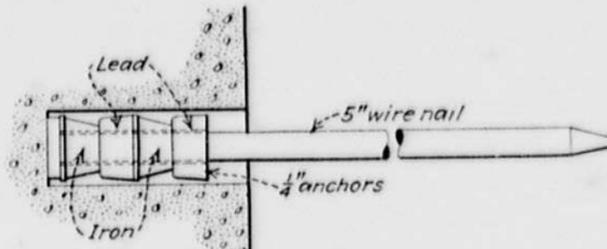
Method of securing nails in concrete by means of lead expansion bolts.

As can be seen from the sketch, lead expansion bolt-anchors utilize the principle of expanding one or more lead alloy cone rings within a hole by calking them over iron cones placed base down on the head of a bolt. The anchorage is also used to anchor the threaded end of the bolt in the hole by using the iron cone tapped with a standard machine bolt thread of any size. They are used for all types of anchorages in concrete and masonry, for installing machinery, motors, shafting, pipe lines, theatre seats, and for electrical, plumbing, heating and ventilating work.

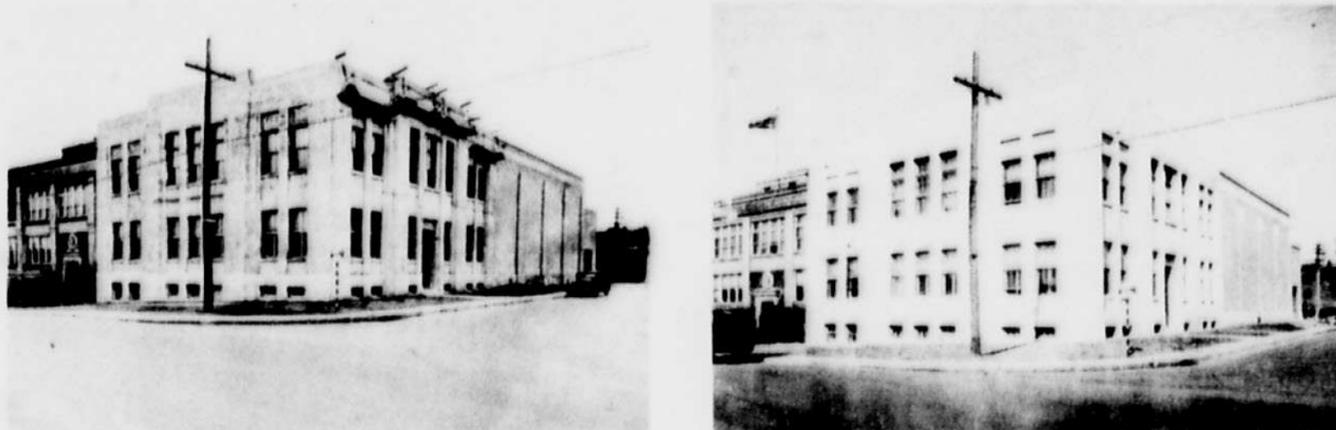
At first glance the two pictures above would hardly seem to show the same building, the one having the appearance of a typical concrete structure, the other suggesting the grace of a beautiful stone building. Yet they are the same; the structure being the new addition to the Associated Screen News Building, Montreal, Quebec. The Architects were J. W. Orrock and N. B. Reardon of the Canadian Pacific Railroad, and the contractors were the A. Janin Construction Company. The office in the foreground is of monolithic concrete, and was subsequently treated with a light colored RESTO-CRETE.

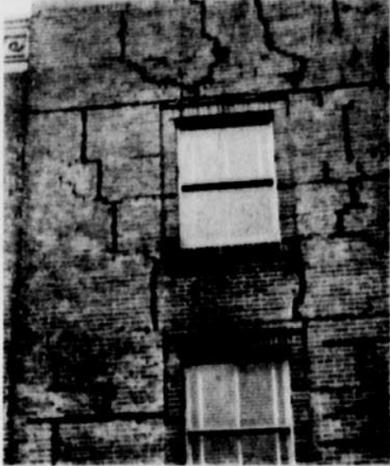
This picture shows the wall with cracks cut down to a solid base preparatory to repointing.

NO, THIS BUILDING did not go through an earthquake! It wasn't even improperly built or designed, according to our modern view, and no settling occurred. The condition is only an exaggerated case of what Mother Nature is doing to all buildings, starting at the time of building and continuing until the wrecker comes to haul them away, as our experience with thousands of similar failures proves.

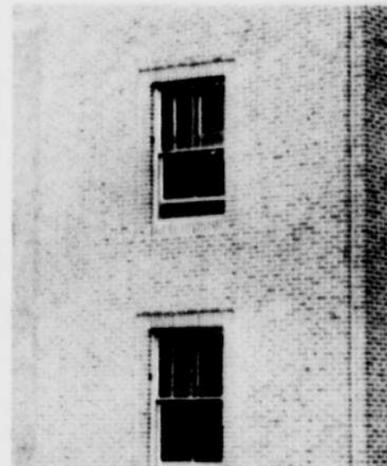
The same building after one year's exposure, following Resto-Crete application.

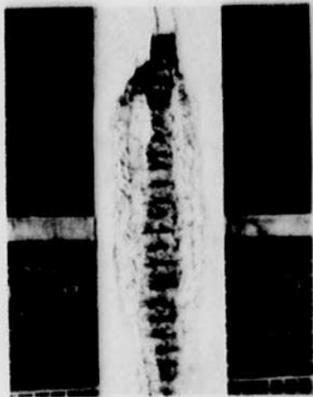
Badly Spalled

Water which entered the concrete by capillarity and rusted the reinforcing bars caused this serious damage

This is what happened to the concrete column shown at the left. Moreover, it happens to a greater or less degree to all reinforced concrete structures. Most concrete structures over a few years old show some spalling on the surface, and at least ninety per cent of these marks of disintegration are due to the rusting of the reinforcing steel.

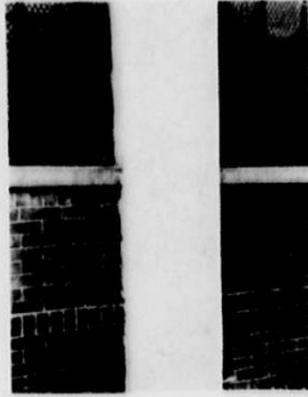
Restored by Resto-Crete

Here is the same column restored to its original strength and permanently protected against further ravages

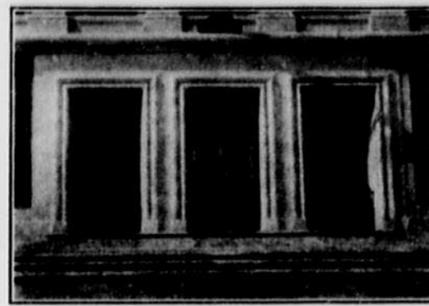
FIG. 2.
Old Limestone Entrance weatherproofed
and decorated by Resto-Crete.

In the left-hand side of Fig. 1, and in Fig. 2, these principles are clearly illustrated. Note that the surface characteristics are in no way altered, but that the open pores are completely filled. No wax or paraffin has been applied to melt and collect dust, or to prevent breathing. No hard glaze has been created to invite surface spalling by the formation of interior salt crystals. The surface performs in accordance with *Natural Laws*, at the same time giving protection against the ravages of water and sulphuric acid.

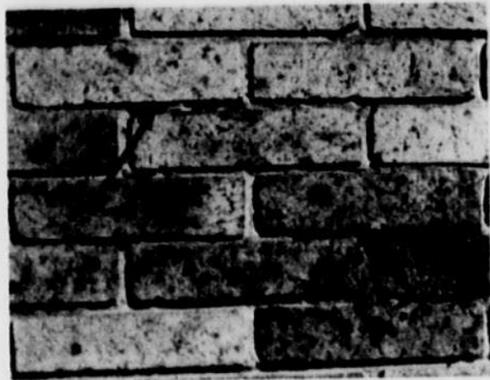
FIG. 1.
Some joints tuck-pointed. Note the extensive disintegration in untreated joint areas which should be repaired. This wall leaks.

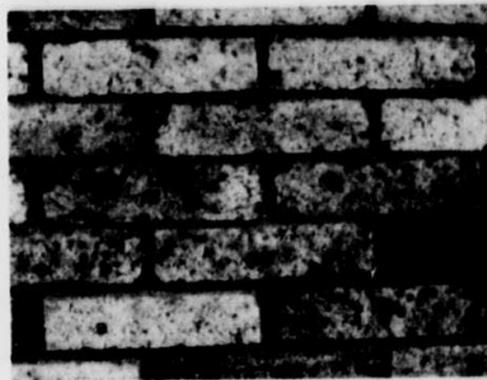
FIG. 2.
Same area as above, but every crack and hole in joints and surfaces completely weatherproofed. Wall doesn't leak.
